NTSB Battery Nail Penetration Tests

Final Report for 787 Battery (Asset 436) Tested at 70°C, Ungrounded

J. Thomas Chapin, PhD
Pravinray D. Gandhi, PhD, PE
Paul W. Brazis, Jr., PhD
May 29, 2014

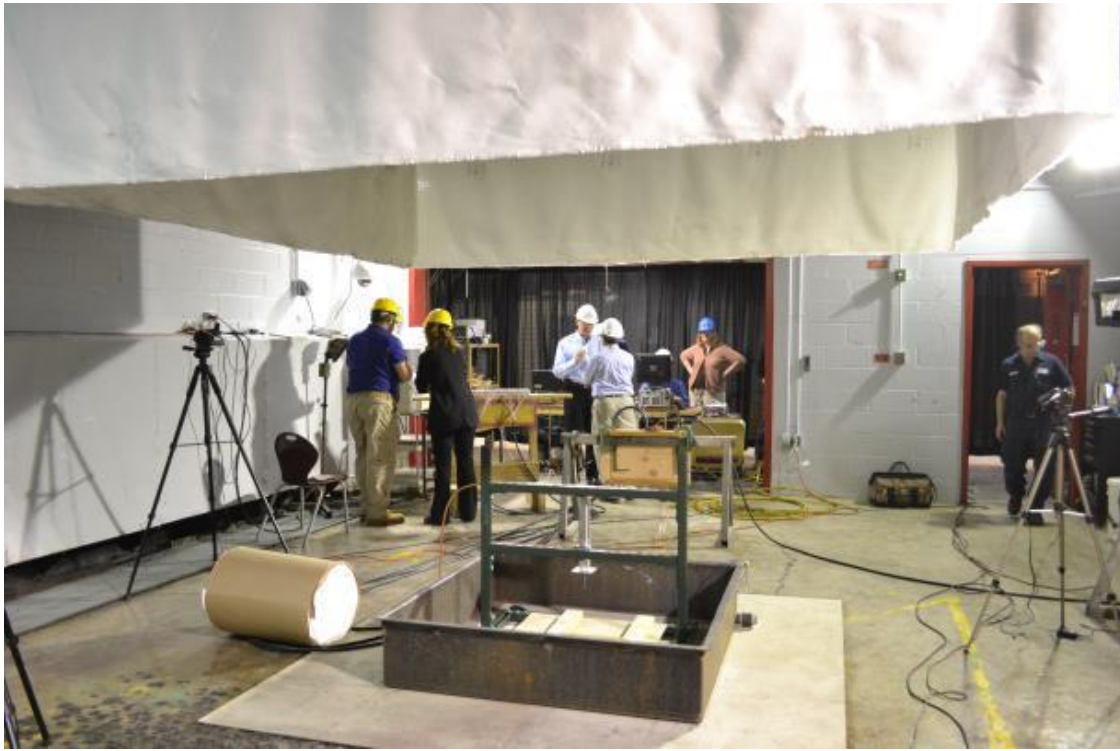
Figure 1. Cell A

The tests were conducted in UL's Cell A test facility. The test cell is a 35 x 35 x 40 ft. high test room equipped with a 14 x 14 ft. collection hood to collect fire effluents (smoke, and gases). The collection hood is connected to UL's smoke abatement system through a 24 in. exhaust duct. Incorporated in the exhaust duct, is an instrumented section for measurement of smoke density and gases from a fire. The smoke density is measured using a photometric system consisting of a white light source and a photo detector to measure the opacity of the smoke. Heat release rate is calculated using an oxygen consumption technique¹. To enable this, duct velocity is monitored using a bi-directional probe, and the exhaust gases are monitored using a paramagnetic oxygen analyzer. The heat release rate system in Cell A has a capacity to measure a maximum 2 MW fire size.

A photograph of the Cell A is shown in Figure 1.

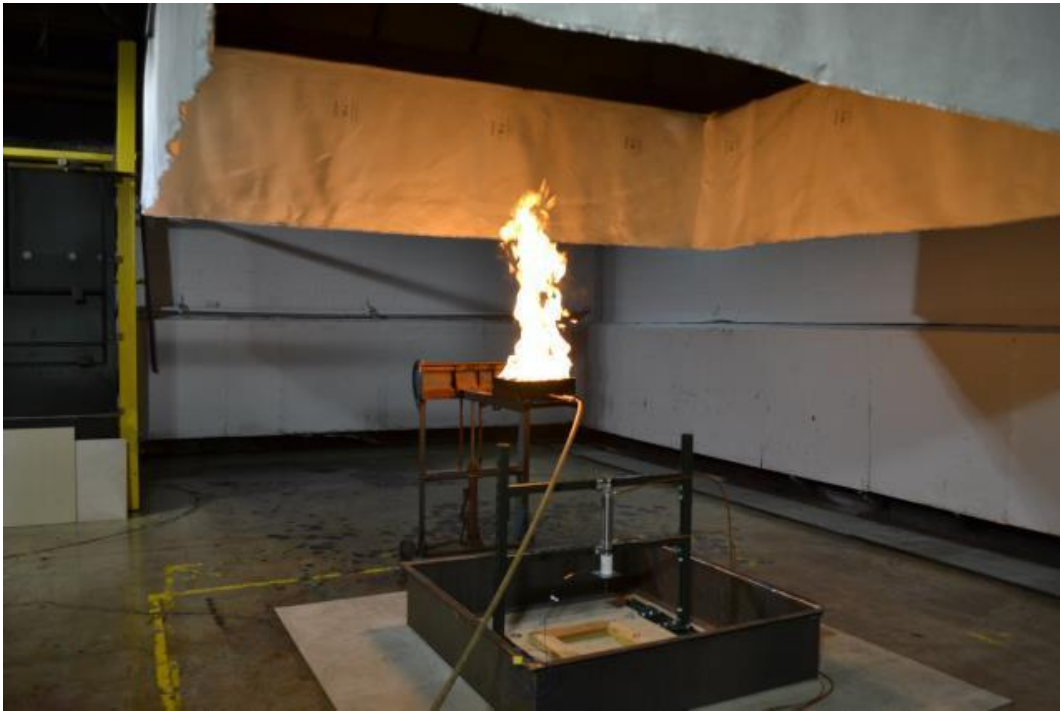
Figure 6 – Heat Release Rate Calibration Set-Up

The heat release rate system was calibrated using propane gas sand burner with known fire sizes of 75, and 200 kW; and a calibration factor was calculated. This range of the calibration fire sizes were selected based upon anticipated fire size during the test. The calibration for heat release rate is depicted in Figure 7. A calibration factor of 0.92 was applied to the calculation of heat release rate data during the test.

A photograph of the set-up used for heat release rate calibration is presented in Figure 6.

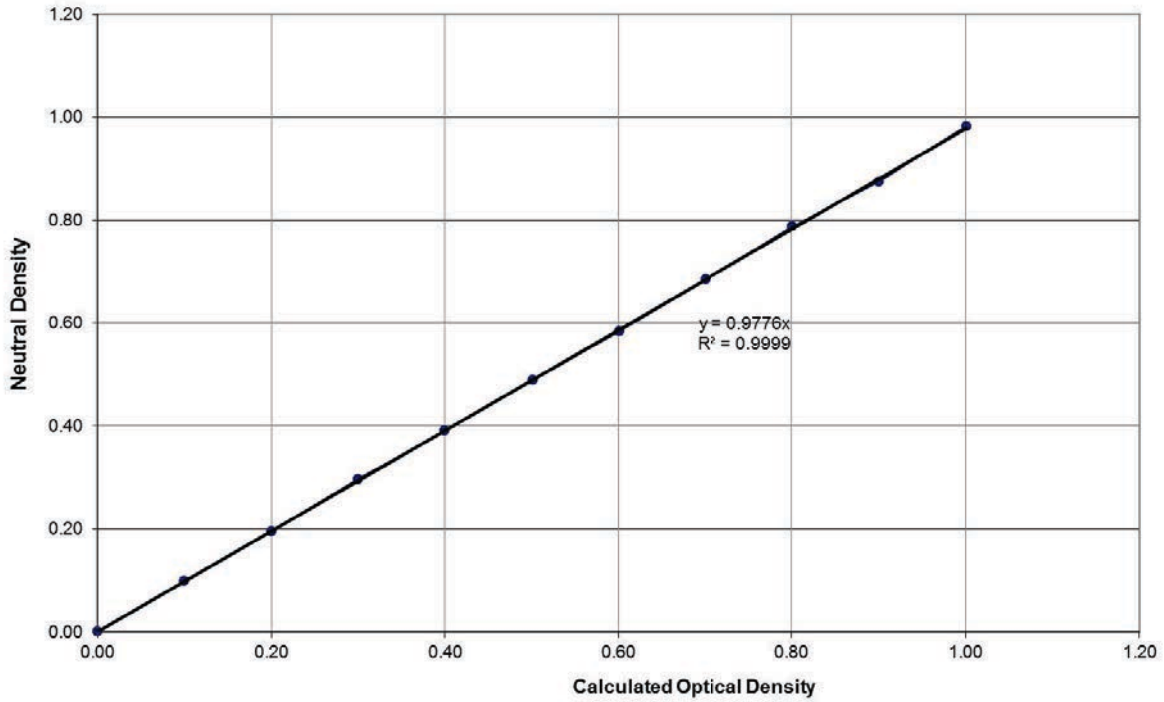
Figure 8. Smoke obscuration system calibration.

A calibration constant was then developed by correlating the calculated optical density with the neutral density filters as shown in Figure 8.

The smoke measurement system was calibrated using neutral density filters. The calibration for the smoke measurement system is shown in Figure 8. A correction factor of 0.98 was applied to the calculated optical density data from the test.

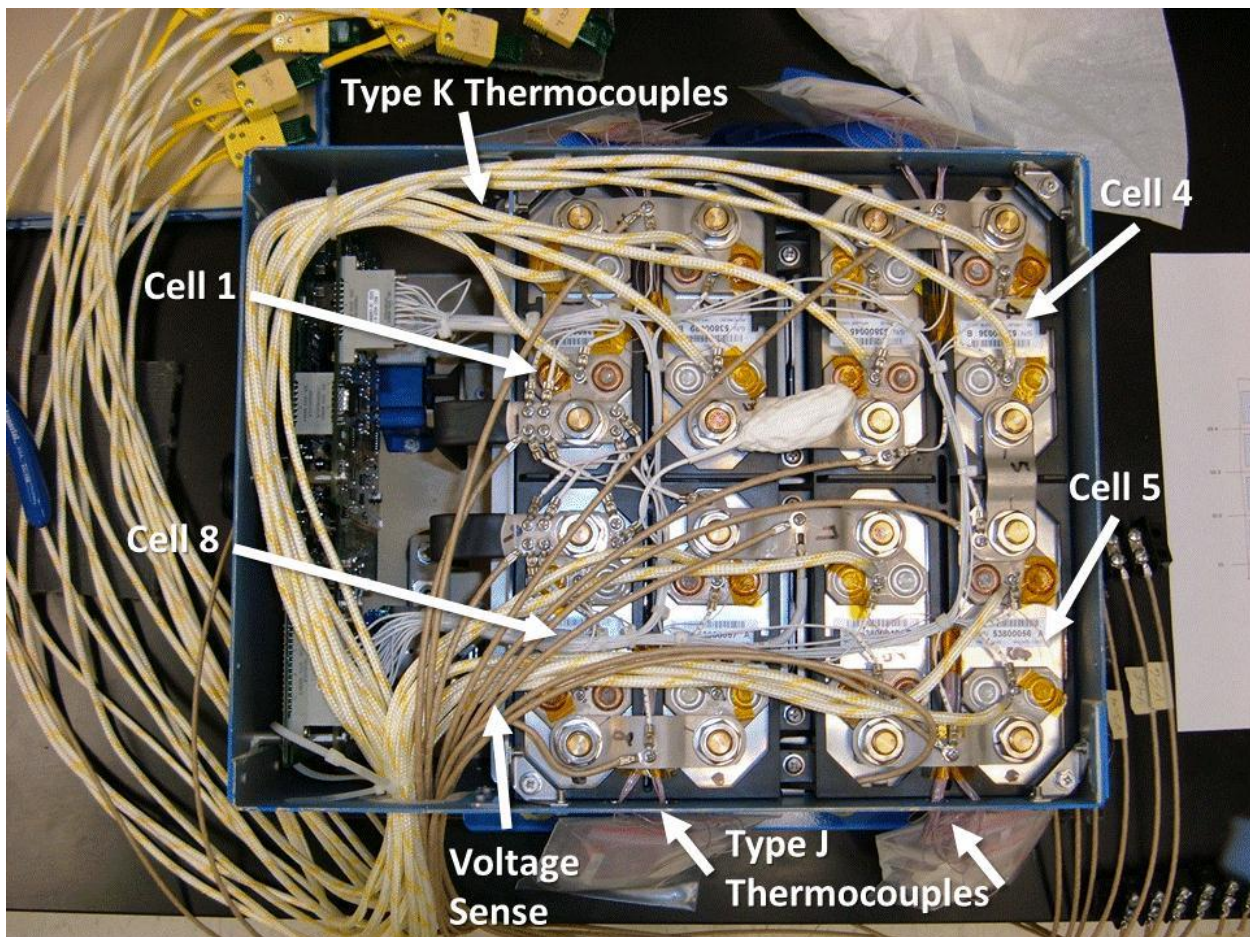
Figure 9. Photo of voltage and temperature sensing wiring for 70°C battery. Image taken before installation of coaxial cabling.

The remaining thermocouples used for temperature measurement were Omega Nextel® Ceramic-Braided Type K thermocouples, XC Series. These thermocouples were 24 AWG and shielded with a ceramic-braided material for increased thermal resistance, rated for continuous use at 1200°C. Sixteen of these Type K thermocouples were added to the top surface (Face 5) of each battery cell, located on the busbars nearest each cell terminal. To optimize the thermal interconnection, the junction was attached directly under voltage sensing screws that are included as a part of the battery construction. For both thermocouple types, locations for each thermocouple are detailed for each cell discussion in the data analysis section.

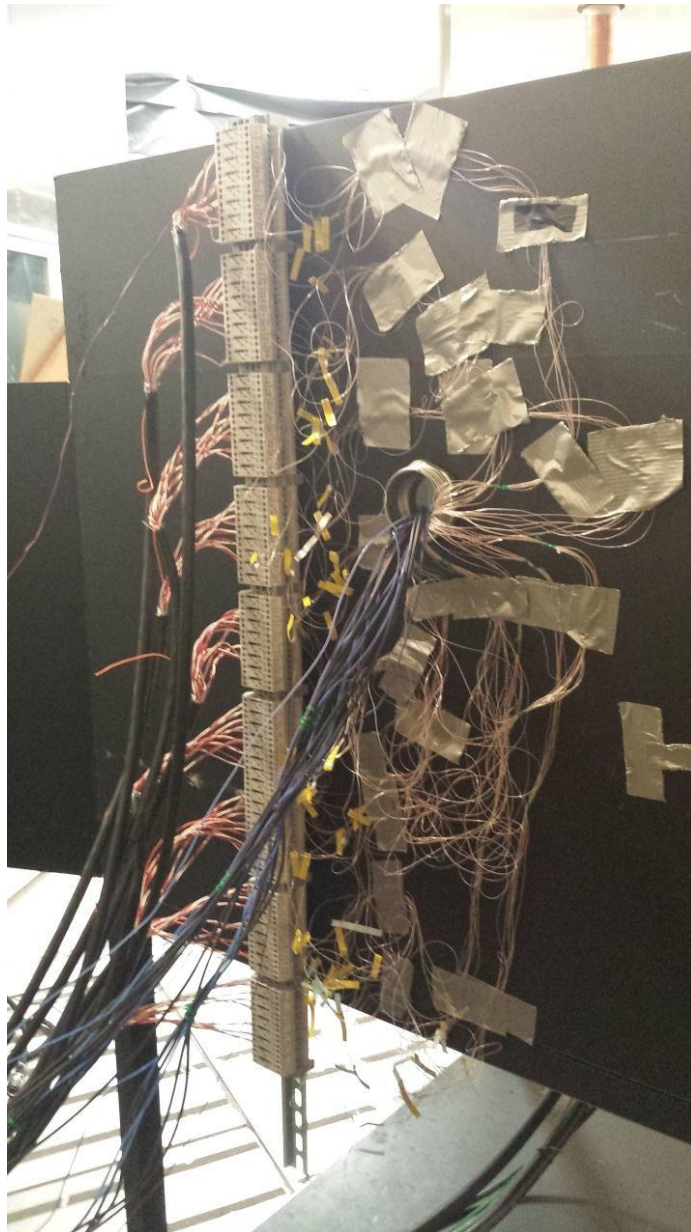
Figure 10. DIN rail interface for Type J thermocouples, shown used during prior non-destructive battery testing.

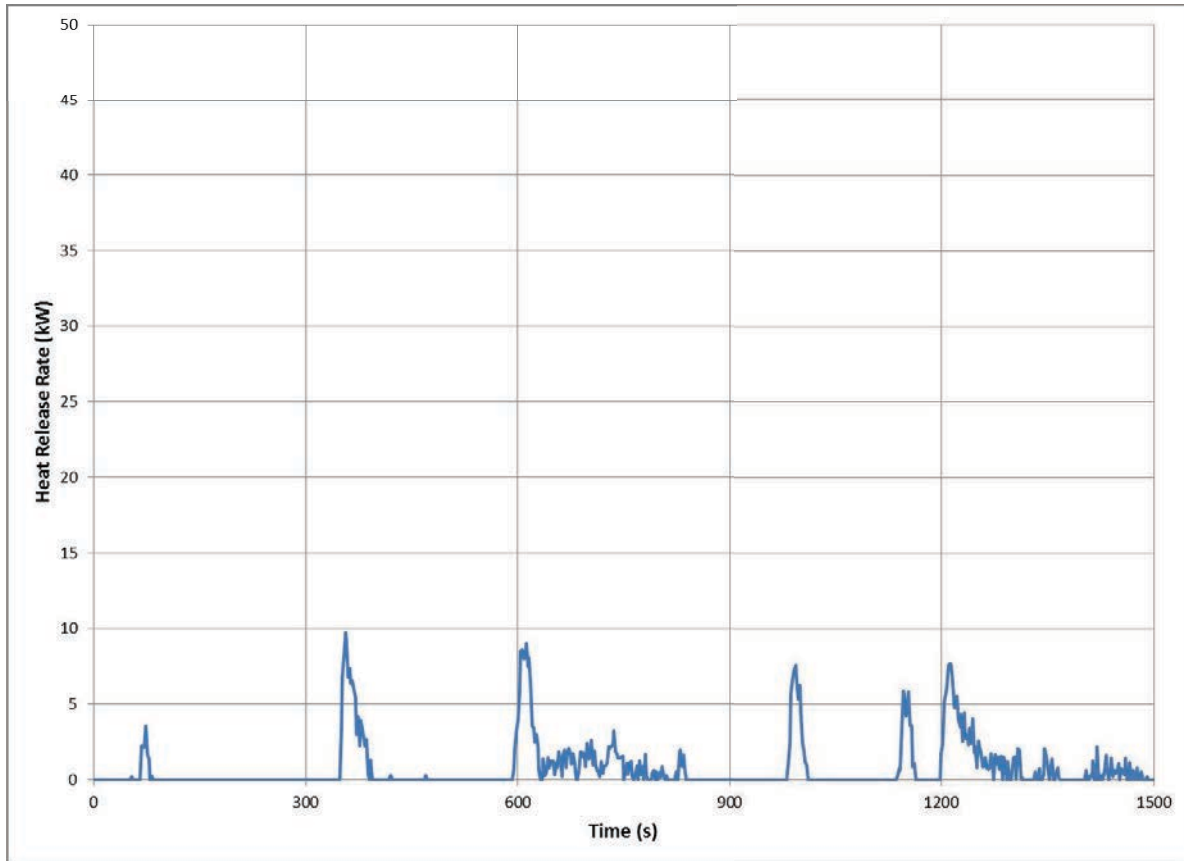
Figure 11. Heat Release Rate data from the 70°C test

The heat release rate data for the test is shown in Figure 11. While no external flaming was observed, the relatively small values heat release rate may be indication of oxidation of the vent gases in air.

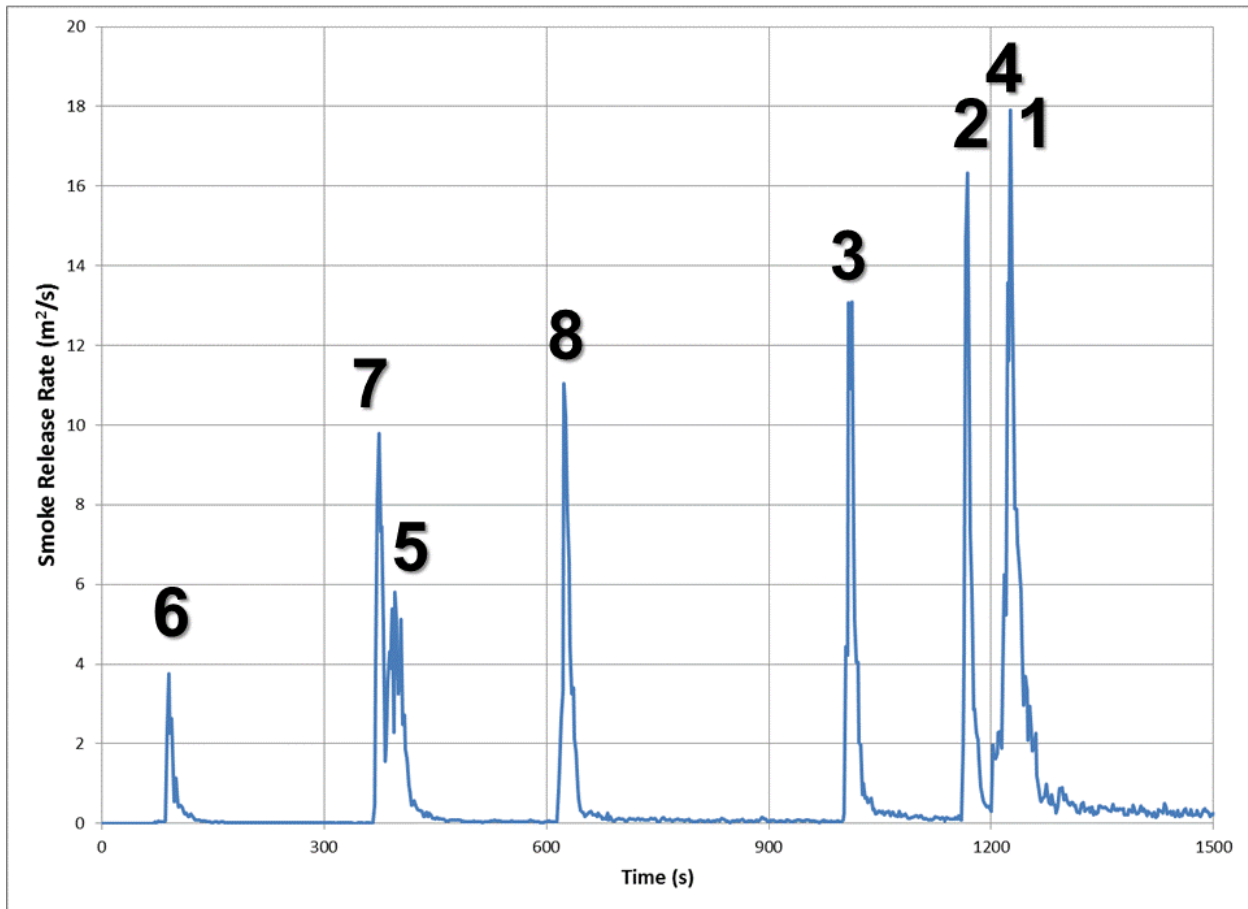
Smoke release rate is calculated using optical density and duct velocity data as shown in Eq. 5. The smoke release rate data are presented in Figure 12. The data shows distinct release of gases after the Cell 6 was shorted with nail penetration procedure, can be correlated with cell temperature and voltage data obtained during the test.

Figure 12. Smoke release rate data from the 70°C test. Numbers in graph denote cell which is venting at the moment of each peak (see Figure 38 for corresponding electrical data).

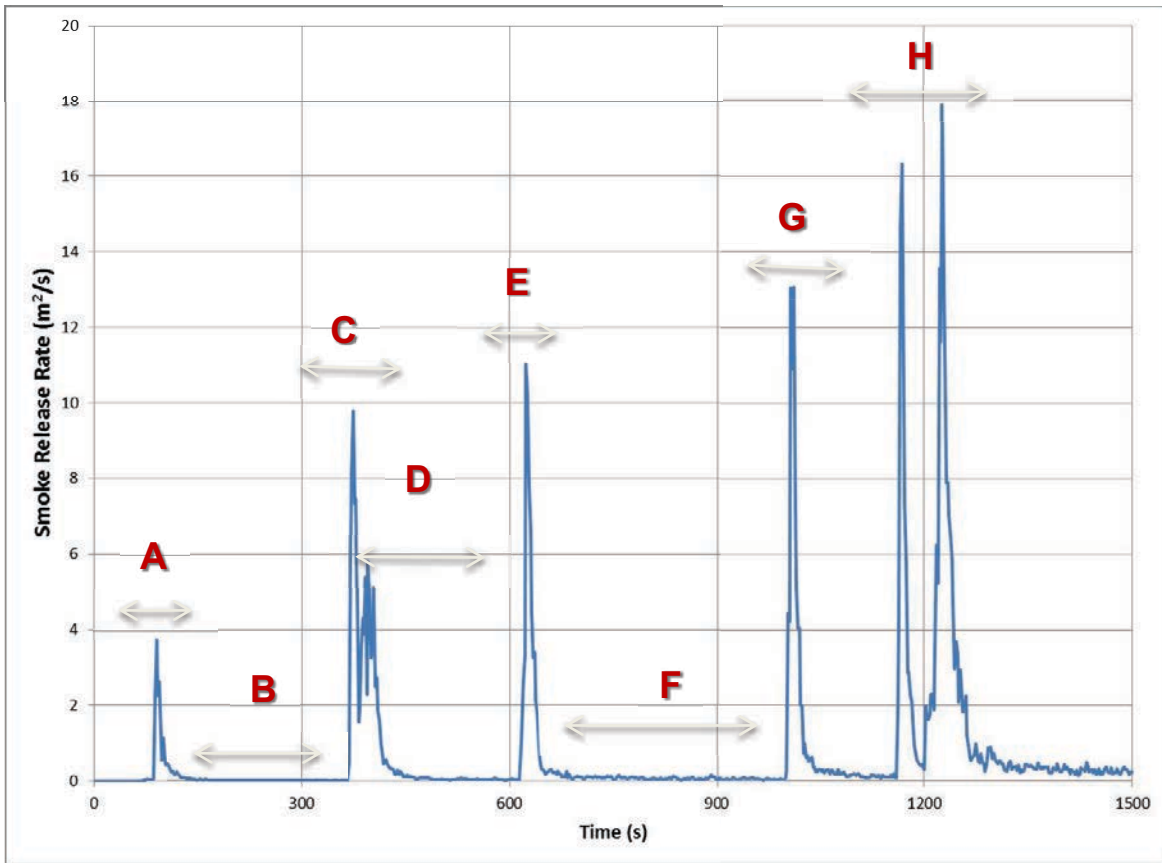
Figure 13 –Vent Events Identified for Gas Analysis

Gas effluent analysis is a specific method to define gas species by using FTIR technique. Aldrich vapor phase sample library, EPA vapor library, and UL in house library were used to identify the species in the effluent. The vent events were tagged as shown in Figure 13 to enable identification of gases related to each vent event.

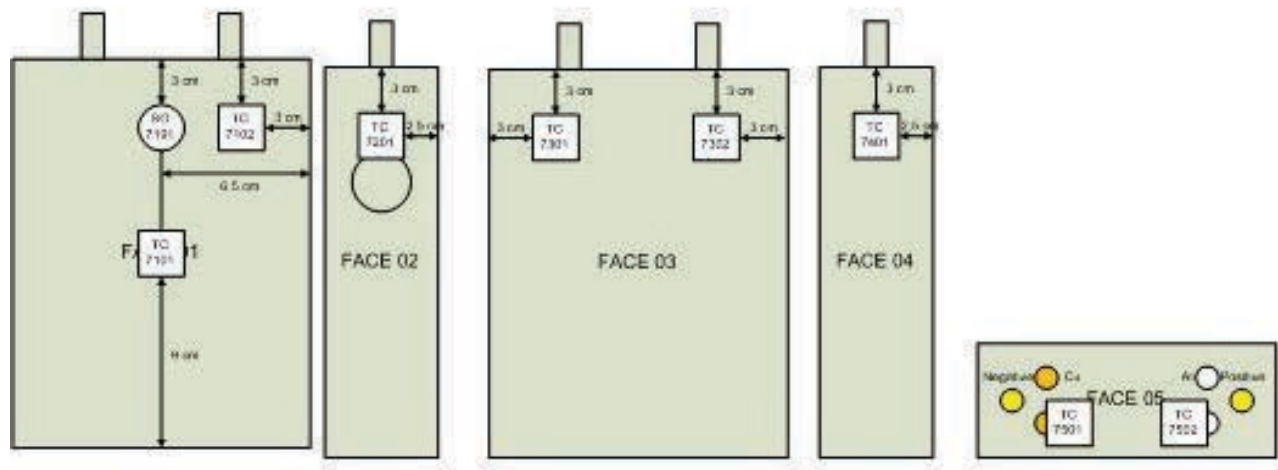
Figure 17. Location of thermocouples attached to Cell 7.

Cell 7 was the second cell to vent, and the first cell to vent after the initial nail penetration event. Failure was due to the transfer of thermal energy from Cell 6 to the negative terminal of Cell 7 through the busbar connected between Cells 6 and 7. This is supported by the rising temperature on thermocouple 7502. Though Face 3 was adjacent to the vented Cell 6, no significant temperature rise was observed; however, the adjacent Face 1 of Cell 6 was measured to have the lowest temperatures of the four faces after venting. Immediately following venting of Cell 6, Faces 2 and 4 of Cell 7 exhibit the most heating, possibly due to thermal transfer from vented gases on Face 2 that is adjacent to the vent hole on Cell 6, Face 2. Face 4 may be receiving conducted heat from Face 4 of Cell 6, which was measured to be at the highest temperature of all Cell 6 faces after venting. After venting of Cell 7, Type J thermocouples begin to lose signal quality, and therefore junction/cable integrity, as the temperature rises above 250°C.

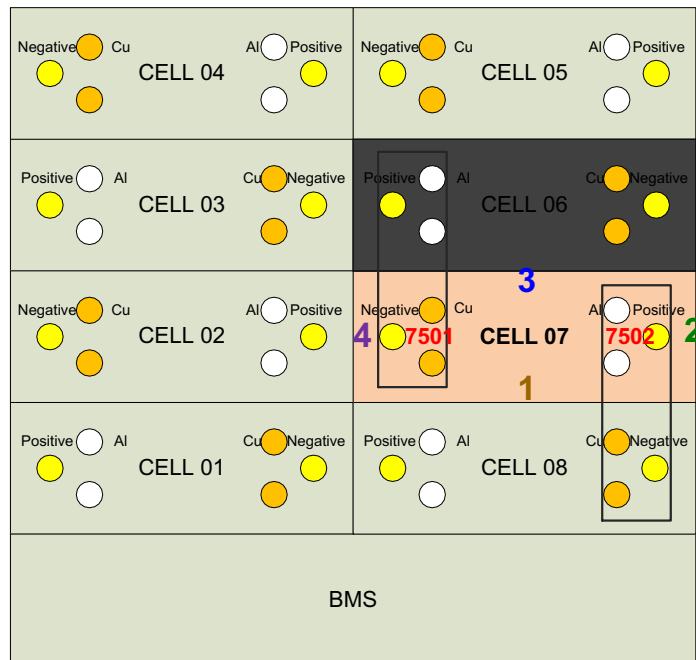
Figure 18. Schematic of the eight cells within the battery, showing location of busbars and designation of each face for Cell 7. Gray shading denotes cells that have previously vented.

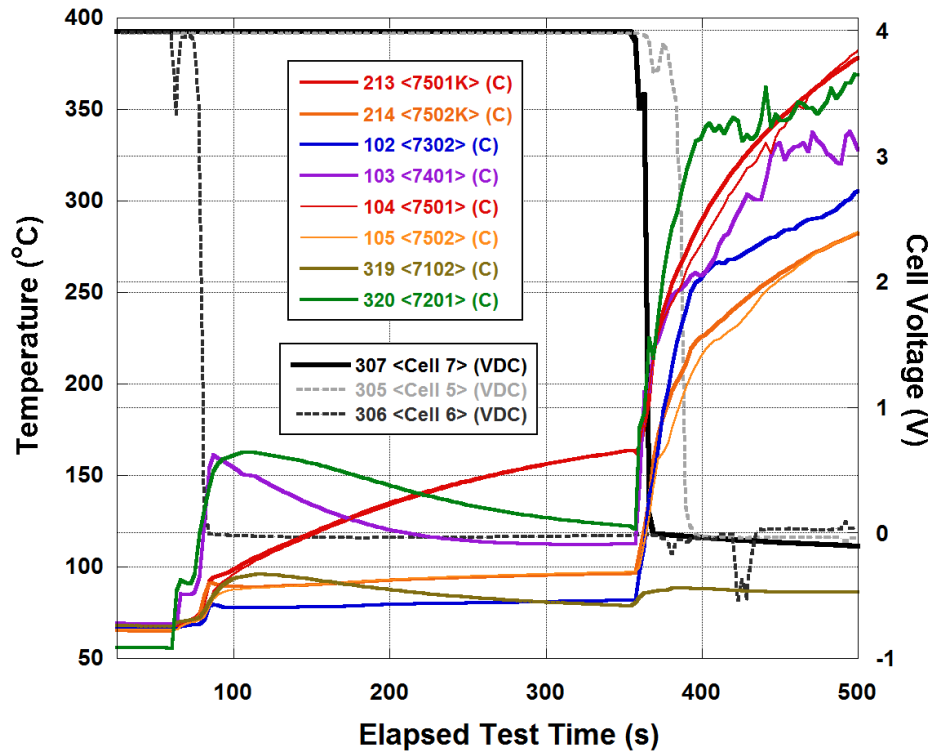
Onset of Initial Voltage Drop	Onset of Voltage Drop to Zero	Immediately After Drop to Zero	Maximum Temp.	Time of Maximum Temp. (s)
Test Time (s)	357	363	369		
Time After Nail Penetration	4:57	5:03	5:09		
Type J TC #7101 (°C)	-	-	-	-	-
Type J TC #7102 (°C)	80.59	85.73	86.4	599.7	1410
Type J TC #7201 (°C)	120.7	184.2	213.8	(580)	897
Type J TC #7301 (°C)	-	-	-	-	-
Type J TC #7302 (°C)	81.70	111.2	147.0	(550)	861
Type J TC #7401 (°C)	112.6	195.4	219.8	(780)	1053
Type J TC #7501 (°C)	163.5	181.7	214.9	511.5	1599
Type K TC #7501K (°C)	163.3	177.2	215.1	531.7	1677
Type J TC #7502 (°C)	97.25	112.9	143.3	-	-
Type K TC #7502K (°C)	96.58	121.0	157.9	516.3	858

Figure 19. Voltage and temperature data for Cell 7 in the vicinity of the venting event.

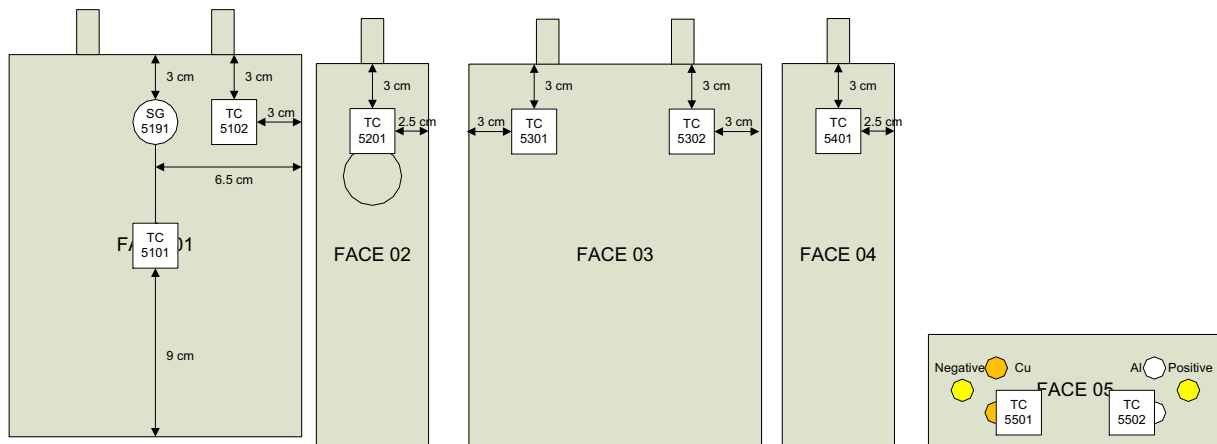
Figure 20. Location of thermocouples attached to Cell 5.

Cell 5 was the third cell to vent. The thermocouple data suggest that the venting was triggered by heat energy carried through the positive terminal along the busbar connected to Cell 6, seen in the data from thermocouple 5502. Heat from Cell 6 was also transferred through Face 1 of Cell 5, seen in the temperature rise on thermocouples 5101 and 5102. Some heating was also observed at Face 2 immediately after venting of Cell 6. Thermocouple 5102 shows higher temperatures than 5101 due to the additional heat energy arriving through the busbar connected to Cell 6. After venting, the temperatures on the sides of the cell (Faces 1, 2, and 3) increase in temperature the most. Increased noise on the Type J thermocouples located at sides 2 and 3 after venting suggest that the circuit integrity of these junctions is lost once temperature approaches 500°C. Face 3 remained below 100°C until Cell 5 vented, likely due to its location away from the venting at Cells 6 and 7.

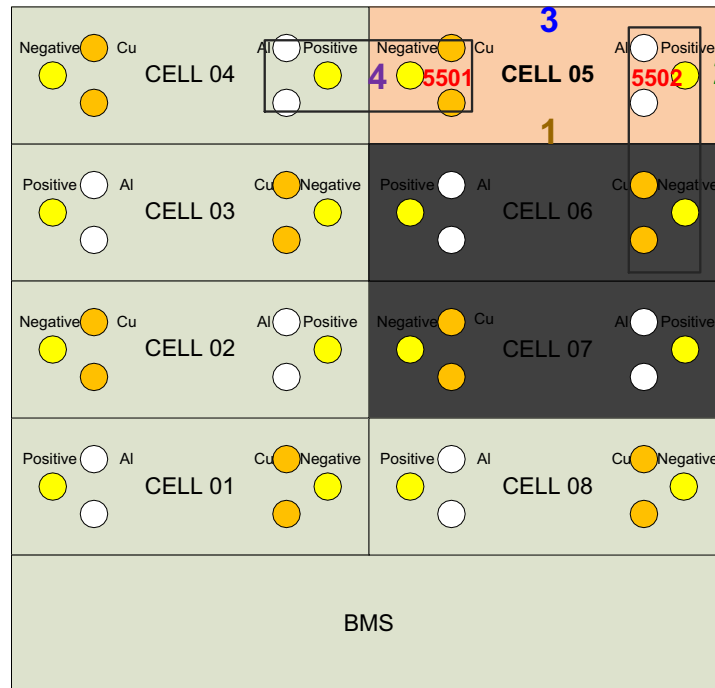
Figure 21. Schematic of the eight cells within the battery, showing location of busbars and designation of each face for Cell 5. Gray shading denotes cells that have previously vented.

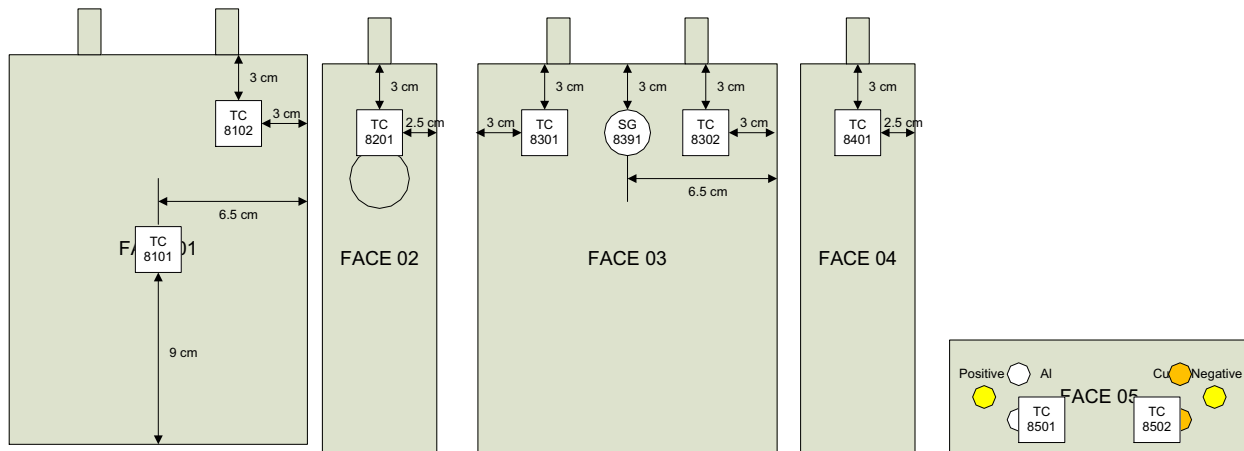
Figure 23. Location of thermocouples attached to Cell 8.

Cell 8 vented approximately 250 seconds after the twin venting events at Cells 5 and 7. Cell 8 received a significant amount of heating from the venting of Cell 7. The most significant temperature rise was at Face 2, which is adjacent to the venting hole at Cell 7, rising to almost 400°C immediately after the Cell 7 venting event. It is possible that the increased heating at Cell 8 was due to flow out of the battery enclosure through a large test lead opening near Face 2, Cell 8. Significant heating was observed on Face 3 of Cell 8, which was adjacent to vented Cell 7. Thermocouple 8301 exhibited higher temperatures relative to thermocouple 8302, likely due to the additional heat transferred from the vented exhaust gases escaping along Face 2 of Cell 8 that was released from the vent hole at Cell 7. Heat transfer through the busbar connected between Cells 7 and 8 was also observed, seen in the thermocouple 8502 data.

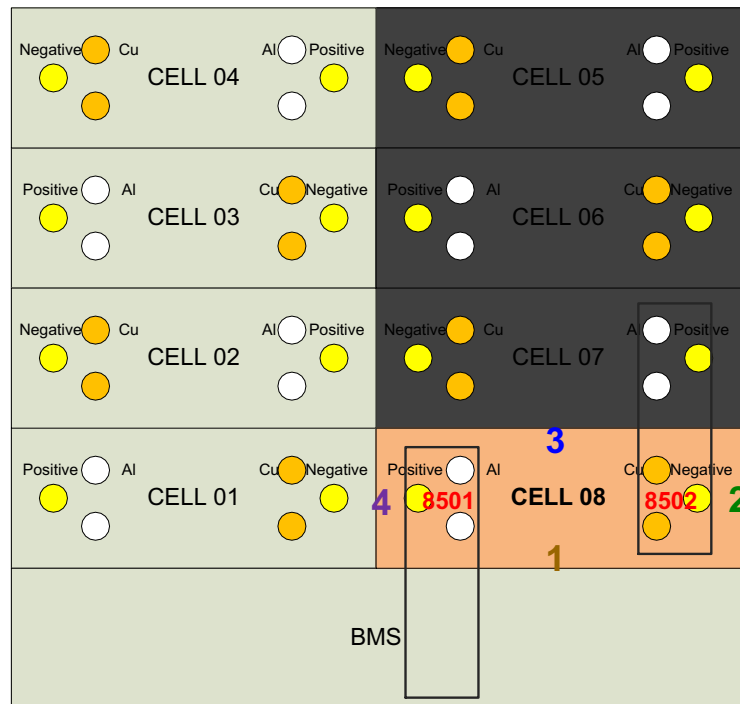
Figure 24. Schematic of the eight cells within the battery, showing location of busbars and designation of each face for Cell 8. Gray shading denotes cells that have previously vented.

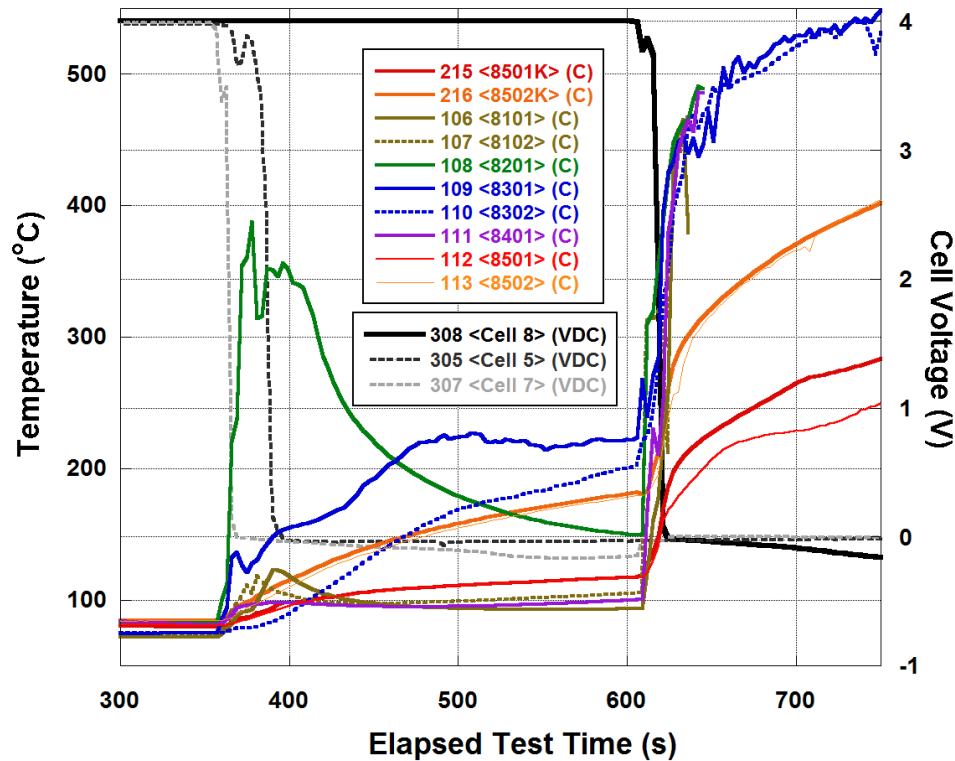
Onset of Initial Voltage Drop	Onset of Voltage Drop to Zero	Immediately After Drop to Zero	Maximum Temp.	Time of Maximum Temp. (s)
Test Time (s)	603	612	621		
Time After Nail Penetration	9:03	9:12	9:21		
Type J TC #8101 (°C)	93.43	121.3	258.0	627.1	1155
Type J TC #8102 (°C)	105.2	313.1	-	607.0	1137
Type J TC #8201 (°C)	149.9	310.0	420.7	677.2	690
Type J TC #8301 (°C)	221.6	239.2	424.9	(550)	753
Type J TC #8302 (°C)	201.1	224.9	348.6	611.6	825
Type J TC #8401 (°C)	99.93	168.0	379.0	554.4	1188
Type J TC #8501 (°C)	116.9	120.9	168.6	(590)	1026
Type K TC #8501K (°C)	117.3	127.4	186.6	416.5	1788
Type J TC #8502 (°C)	178.7	180.9	238.7	(440)	834
Type K TC #8502K (°C)	181.6	182.7	261.2	484.4	1152

Figure 25. Voltage and temperature data for Cell 8 in the vicinity of the venting event.

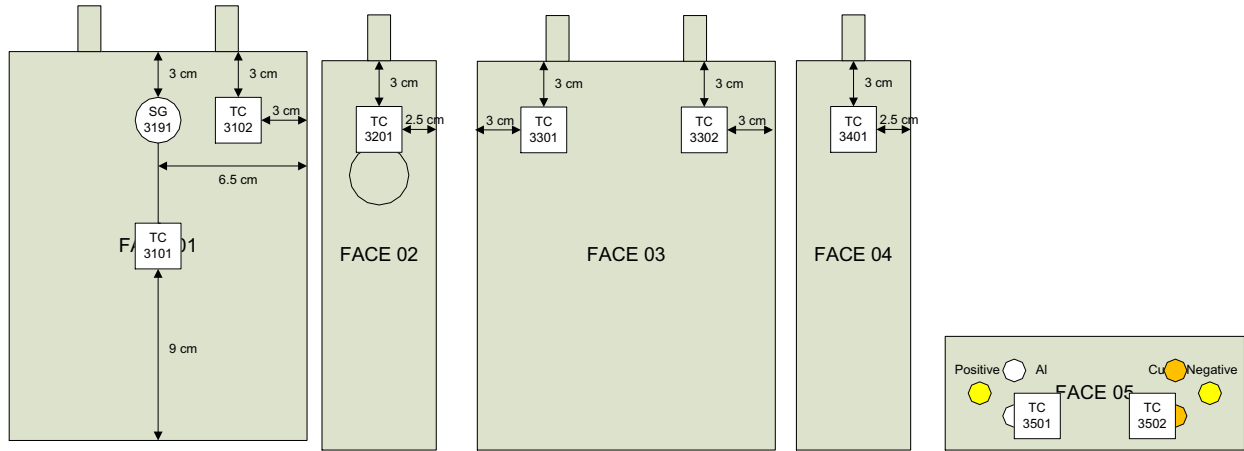
Figure 26. Location of thermocouples attached to Cell 3.

Cell 3 was the first cell to vent on the side opposite of the nail penetration event (Cells 1-4). The duration between Cell 8 venting and Cell 3 venting was the longest span of time between any other two venting events (more than 350 seconds). Venting appears to have been caused by heat transfer to Face 4 of Cell 3 from the vented Cell 6, maintaining temperatures at Face 4, Cell 3 above 300°C. Face 3 is also at an elevated temperature, holding above 200°C before Cell 3 vents. It is likely this is heat transferred from the venting events at Cells 7 and 8. The busbar closest to Cell 6 (at thermocouple 3502) shows increased heating, likely as a result of heat traveling Cell 6, possibly through Face 4 and into Cell 3, and then up into the busbar. As with other venting events, heating after venting is most significant at the vent hole on Face 2, as well as significant heating at the busbars leading from the cell. Several Type J thermocouples ceased to operate around the time of venting of Cell 3.

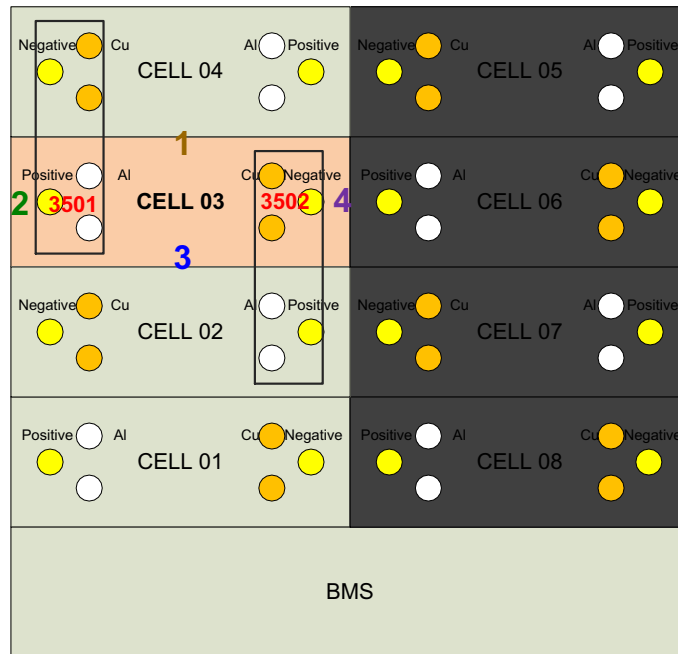
Figure 27. Schematic of the eight cells within the battery, showing location of busbars and designation of each face for Cell 3. Gray shading denotes cells that have previously vented.

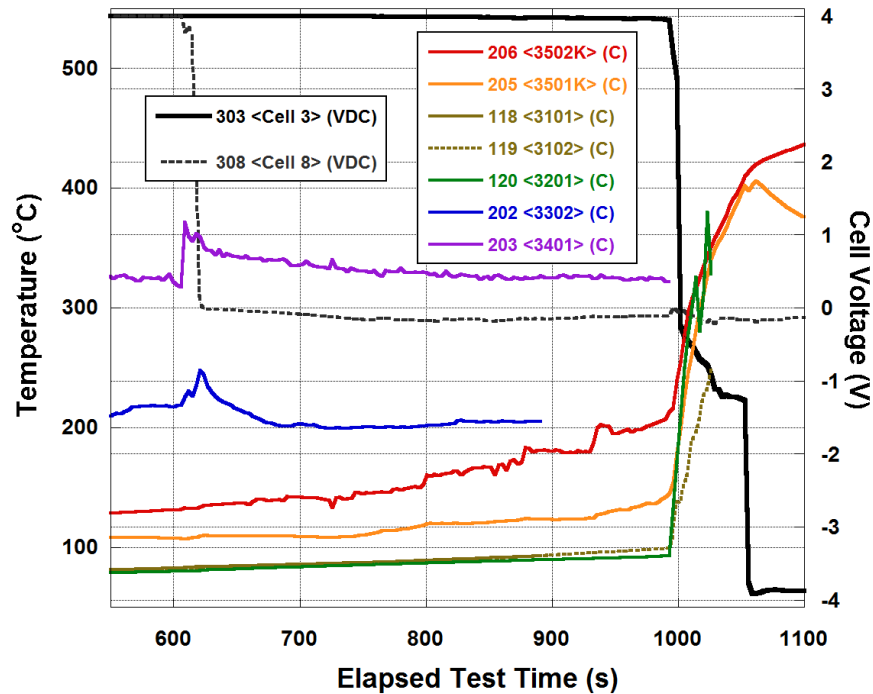
Onset of Initial Voltage Drop	Onset of Voltage Drop to Zero	Immediately After Drop to Zero	Maximum Temp.	Time of Maximum Temp. (s)
Test Time (s)	993	999	1002		
Time After Nail Penetration	15:33	15:39	15:42		
Type J TC #3101 (°C)	-	-	-	-	-
Type J TC #3102 (°C)	99.11	138.3	137.6	(560)	1488
Type J TC #3201 (°C)	92.68	-	-	-	-
Type J TC #3301 (°C)	-	-	-	-	-
Type J TC #3302 (°C)	-	-	-	-	-
Type J TC #3401 (°C)	321.5	-	-	-	-
Type J TC #3501 (°C)	-	-	-	-	-
Type K TC #3501K (°C)	113.7	178.3	198.8	664.4	1191
Type J TC #3502 (°C)	-	-	-	-	-
Type K TC #3502K (°C)	212.7	238.6	254.8	533.7	1755

Figure 28. Voltage and temperature data for Cell 3 in the vicinity of the venting event.

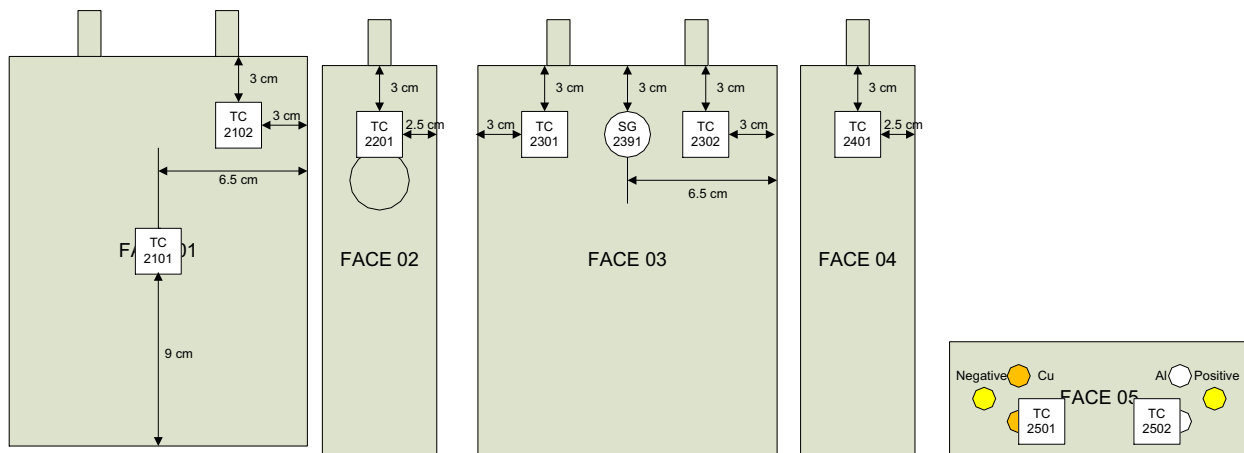
Figure 29. Location of thermocouples attached to Cell 2.

After the venting of Cell 3, the two adjacent cells 2 and 4 were triggered into failure as well. Venting of Cell 2 was the first of these two events to occur. Venting was most likely triggered through heat transfer from the vented Cell 7 applied to Face 4 of Cell 2, which was nearly 400°C several minutes before the Cell 2 venting event. Additional heat energy was applied immediately after the venting of Cell 3 at Face 1 closest to the vent hole on Face 2, Cell 3. Since the temperature rise closer to the vent hole (thermocouple 2102) was much higher than that observed at the center of Face 1 (thermocouple 2101), it is concluded that the heat source was centered around the venting event through the vent hole of Cell 3. It is possible that the applied temperature at thermocouple 2102 rose much higher than the peak at 480°C, as the temperature data is reminiscent of a damaged thermocouple. The lower rise in temperature on Face 2 suggests that the vented gases from Cell 3 did not pass along Face 2 of Cell 2, and that most of the heat transfer from the venting event was from cell case to cell case. As with the other cells, the temperatures of the cell sides 1-4 rose at a faster rate than that observed at the busbars. As in other venting events, several of the Type J thermocouples ceased to operate several seconds after the venting event.

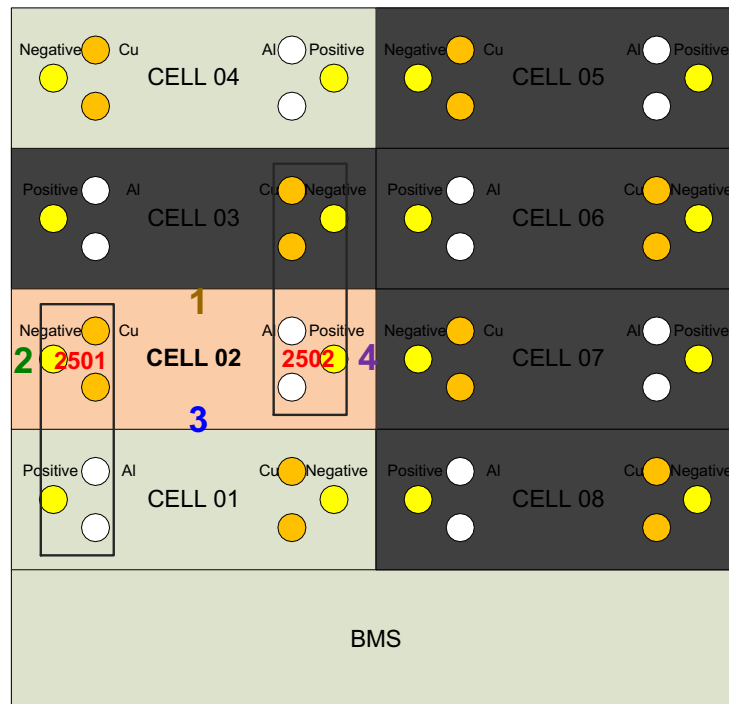
Figure 30. Schematic of the eight cells within the battery, showing location of busbars and designation of each face for Cell 2. Gray shading denotes cells that have previously vented.

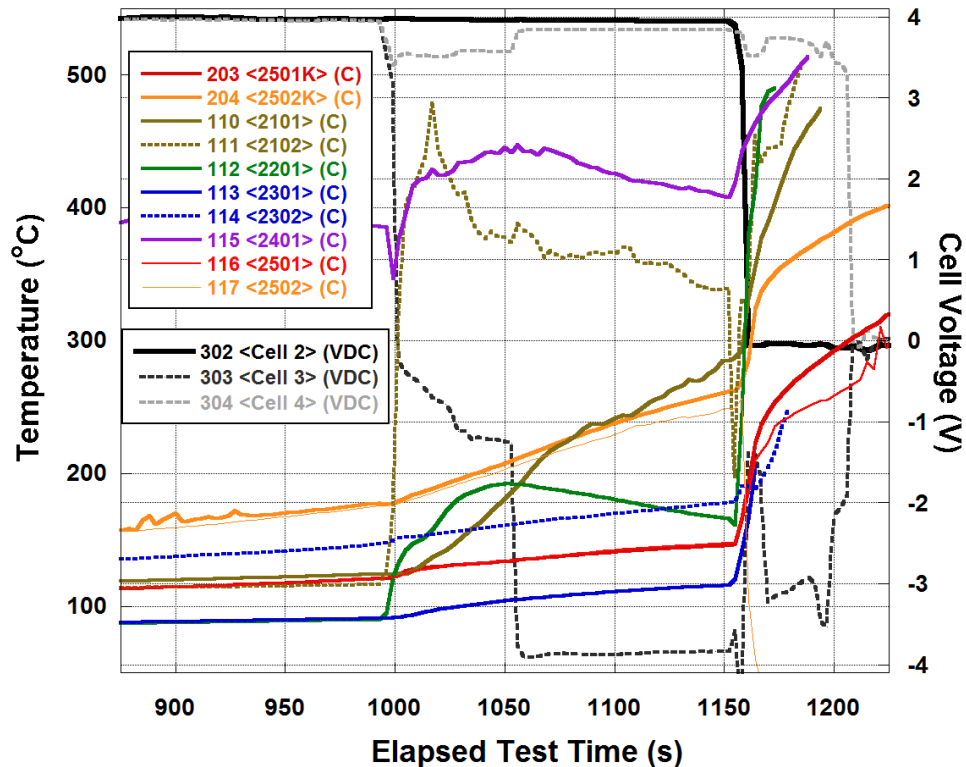
Figure 31. Voltage and temperature data for Cell 2 in the vicinity of the venting event.

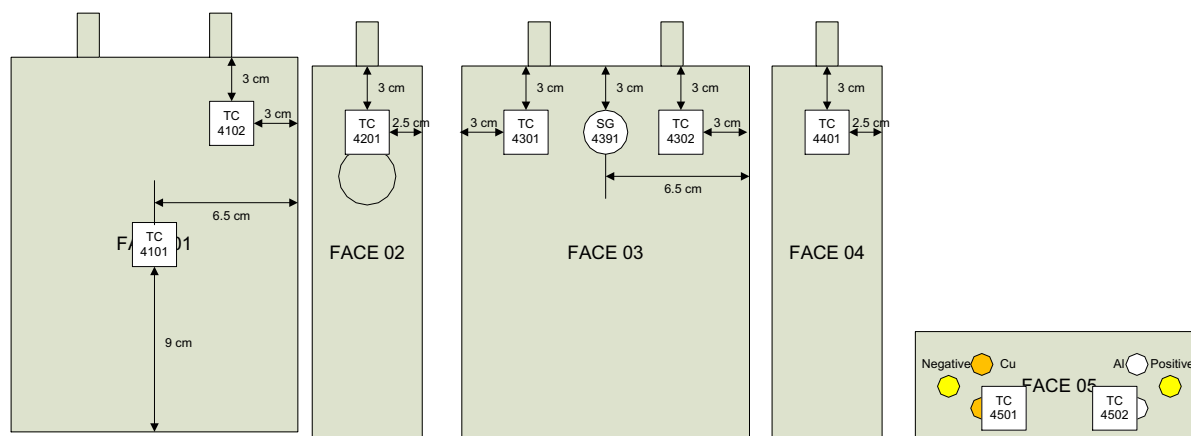
Figure 32. Location of thermocouples attached to Cell 4.

Like the venting of Cells 5 and 7, Cells 2 and 4 were twin venting events triggered by an adjacent venting cell (Cell 3). However, the thermal and electrical data from Cell 4 suggest that venting was triggered through (at least in part) by external shorting of the cell. Significant heating from the previously vented Cell 5 is also observed at Face 4 (thermocouple 4401), with sustained temperatures above 300°C measured. This heating shows a marked increase immediately following venting of Cell 3.

Additional heat energy was transferred across the busbar from Cell 3 to Cell 4 after venting of Cell 3 (observed on thermocouple 4501). This transfer of heat increased further after the venting of Cell 2. This heat transfer may have contributed to triggering the venting of Cell 4.

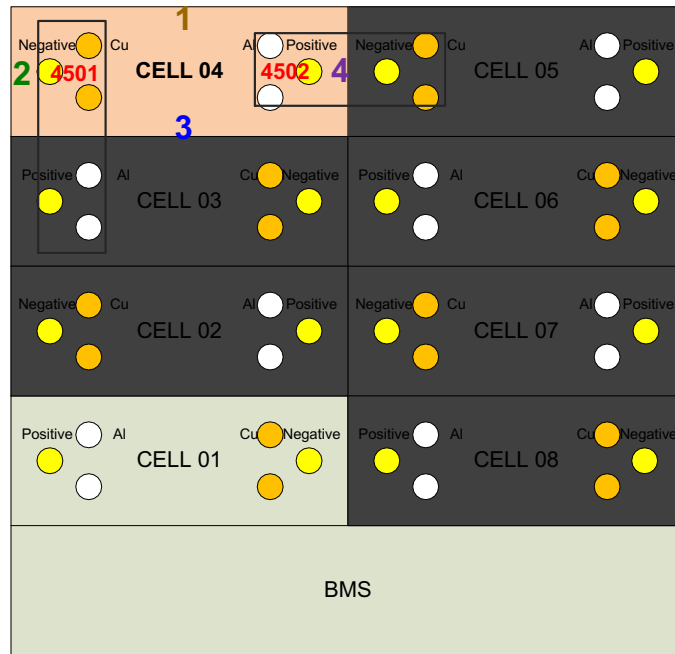
Figure 33. Schematic of the eight cells within the battery, showing location of busbars and designation of each face for Cell 4. Gray shading denotes cells that have previously vented.

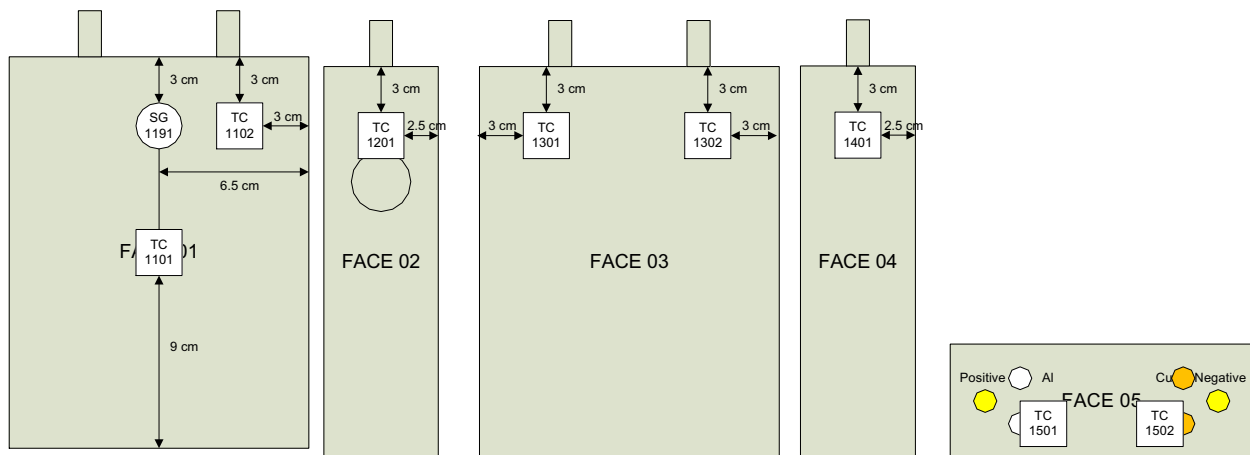
Figure 35. Location of thermocouples attached to Cell 1.

The last cell to vent was Cell 1. The voltage sense lead for Cell 1 failed soon after the test began, so time of failure on this cell is estimated through observation of thermal measurements and voltage measurements across the battery. The temperature data suggest that venting of Cell 1 was induced through heat transfer to Face 1 of Cell 1 from the vented Cell 2. This is supported by the significant temperature rise observed on thermocouples 1101 and 1102. As in the case of prior cells, the temperature on Face 1 closest to Face 2 is significantly higher (more than 50°C) than at the face center, suggesting that much of the heat energy from the venting of Cell 2 was centered near the vent hole (and therefore Face 2). Since thermocouple 1401 was not responsive at the time of the venting event, it is not known to what extent heat transfer from the vented Cell 8 to Face 4 of Cell 1 contributed to the venting event. A small drop in temperature was observed immediately prior to the venting of Cell 1. The source of this is not understood at this time. It is unlikely attributed to electrical current flow, since the negative terminal of Cell 1 was at open circuit and the other cells were at zero volts at the time of the cooling event. It is possible this is a result of cessation of Cell 4 providing current to short-circuit pathways, but the data are insufficient to fully explain the nature of this cooling effect.

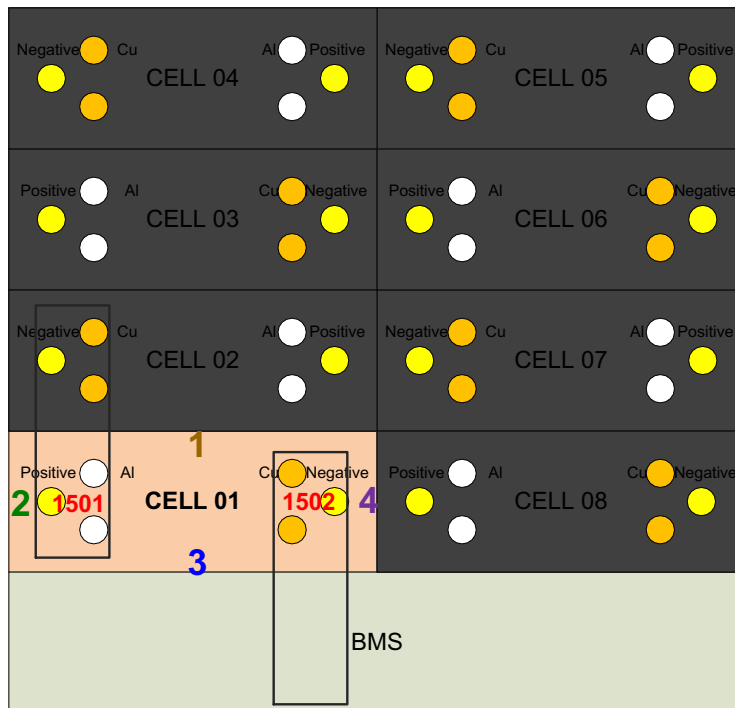
Figure 36. Schematic of the eight cells within the battery, showing location of busbars and designation of each face for Cell 1. Gray shading denotes cells that have previously vented.

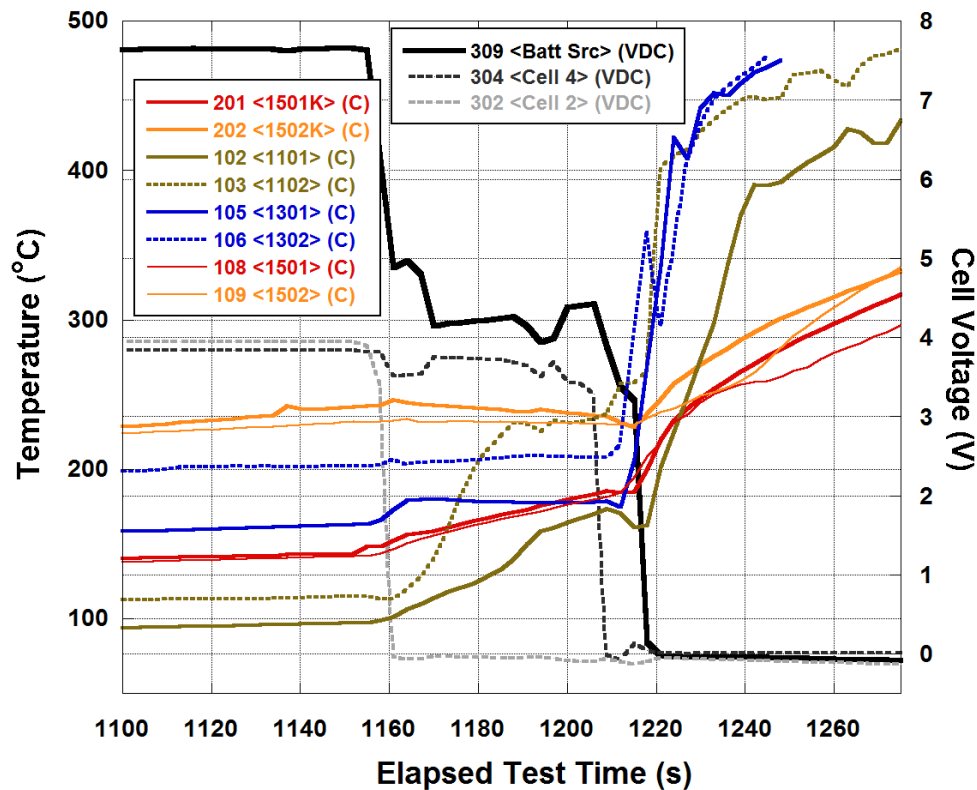
Figure 37. Voltage and temperature data for Cell 1 in the vicinity of the venting event.
